## KENTUCKY INDIVIDUAL BUILDINGS SURVEY FORM

COUNTY Kenton  
RESOURCE # KECP-006  
EVALUATION N  
SHPO EVALUATION \_\_\_\_\_  
DESTROYED \_\_\_\_\_1. NAME OF RESOURCE (how determined): 3 /  
George J. Gerwe House2. ADDRESS/LOCATION: 1605 Russell Street, Covington, KY  
410116. UTM REFERENCE:  
Quad. Name: Covington  
Date: 2010 / Zone: 16 / method: H  
Easting: 7 / 1 / 5 / 3 / 7 / 8 /  
Northing: 4 / 3 / 2 / 7 / 5 / 9 / 5 /4. OWNER/ADDRESS: Stephen Dickman, 85 Concord Avenue,  
Fort Thomas, KY 410755. FIELD RECORDER/AFFILIATION: Margo Warminski6. DATE RECORDED: October 13, 20127. SPONSOR: City of Covington8. INITIATION: 4 /9. OTHER DOCUMENTATION/RECOGNITION:  
\_\_\_\_ Survey \_\_\_\_\_ HABS/HAER  
\_\_\_\_ KY Land \_\_\_\_\_ Local Land  
\_\_\_\_ NR \_\_\_\_\_ NHL

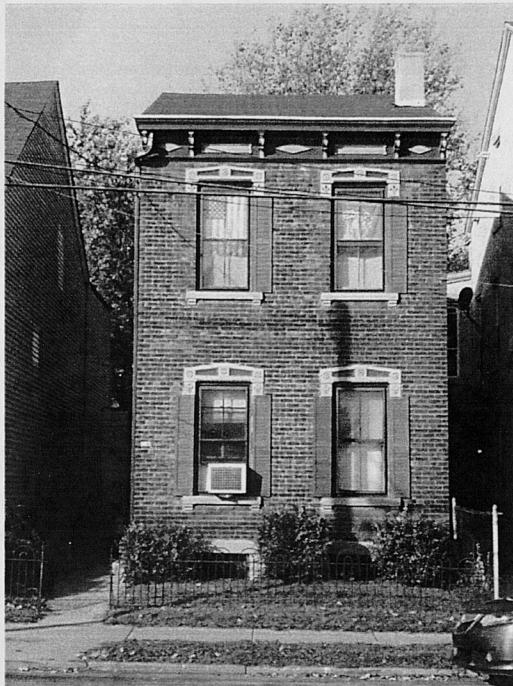
CATEGORY #'s 25 \_\_\_\_\_  
PAGE 3 OF 5 PAGES

"Classic" Covington-Newport brick townhouse of modest scale. Main façade contains 2 windows at each level; main doorway in 1<sup>st</sup> bay position of south elevation. Shallow, shed-roofed, 1-story projection at rear, with shallow frame extension. Façade bays accented by carved, pedimented, geometrical stone headers with impost blocks, and bracketed sills. Bracketed cornice with diamond and rectangular designs in relief. Original 2/2 dhs windows with aluminum storm sash added. Simple, double-hairpin iron fence defines front lot line. George J. Gerwe, shoemaker, and George T. Gerwe, clerk, were owner-occupants here in 1928. By 1938 George Sr.'s widow Anna lived here; the directory indicates that, unlike many of her neighbors, she had a telephone.
